# CHULA VISTA FIRE DEPARTMENT

# GREEN SHEET

## Informational Summary Report of Serious CVFD Injuries, Illnesses, Accidents, and Near Serious Accidents

### Action Footwear Commercial Structure Fire and Serious Burn Injuries January 25, 2021

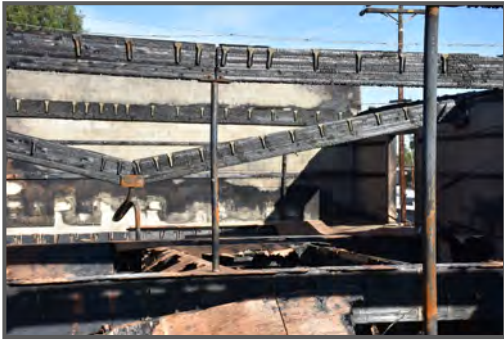
Middle Landing towards C/D

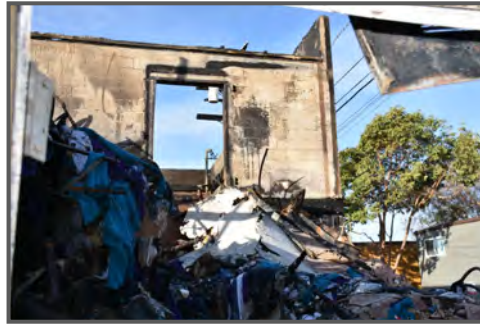
Stairwell and landing from C/D ground

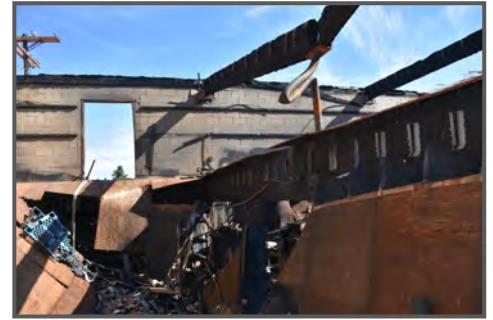
Looking at interior C/D corner with abandoned hose

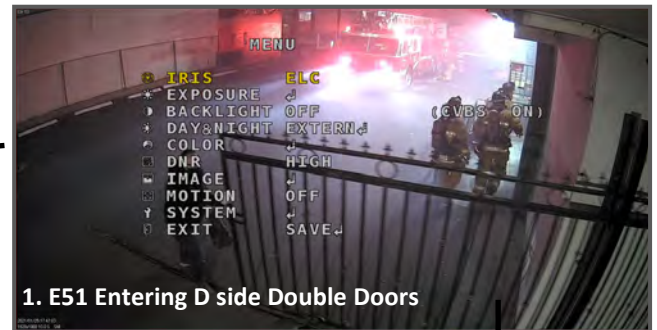
1. E51 Entering D side Double Doors

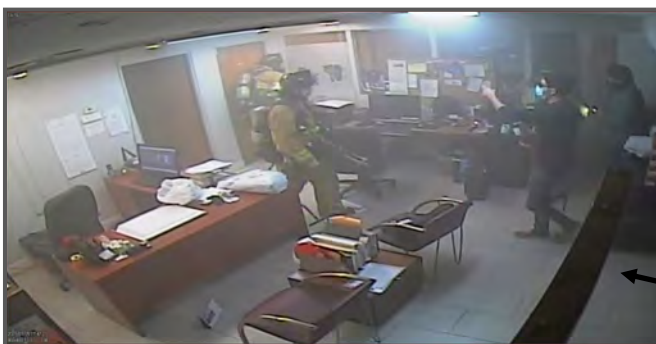
4. E51 attempting to open door to stairwell

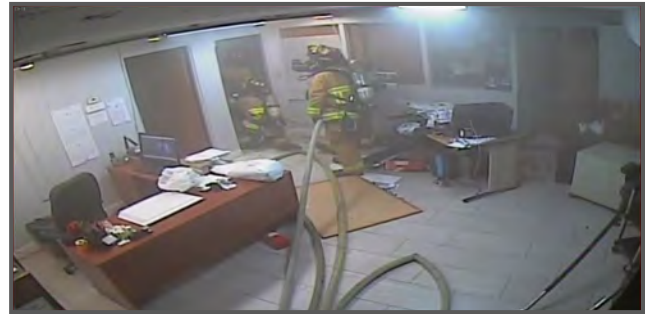
E52 and E55 attacking the fire

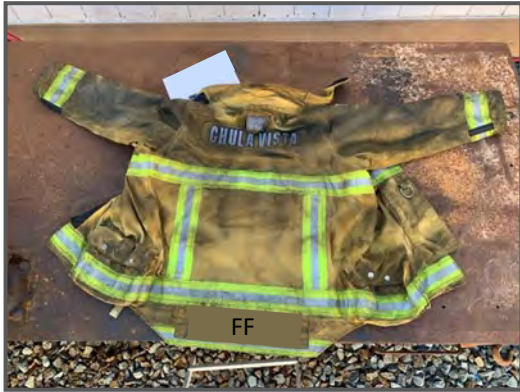
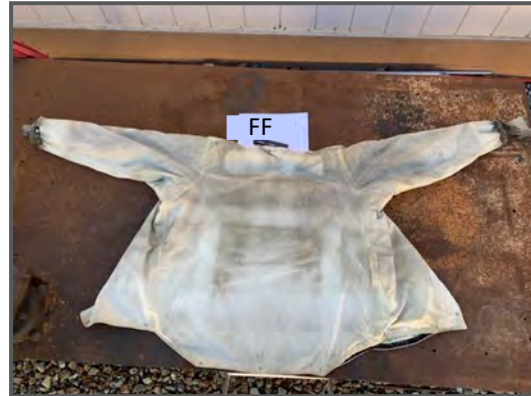
All PPE from the members with burn injuries was collected, cataloged, inspected, and sent to Honeywell for testing. Findings will be provided in a later report. The PPE of the burned personnel shows thermal damage from an extended exposure to radiant heat over head. There is no evidence of direct flame impingement to the gear.

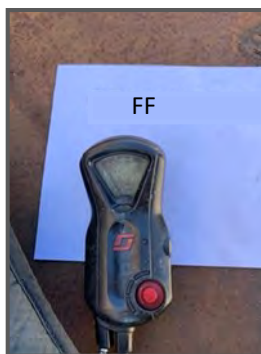
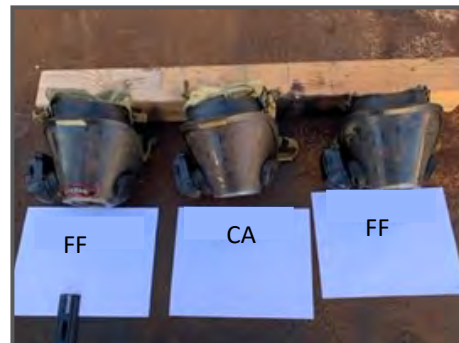
Self-Contained Breathing Apparatus (SCBA) and facepieces were inspected by Scott Fire and Safety. The Scott technicians deemed all equipment, with exception of the cylinders, damaged beyond repair and taken out of service.

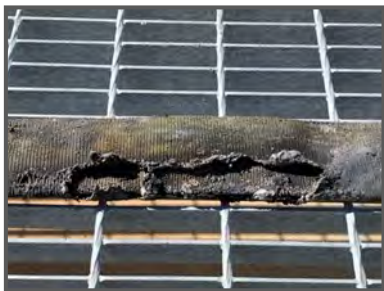
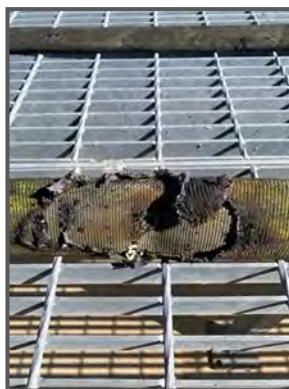
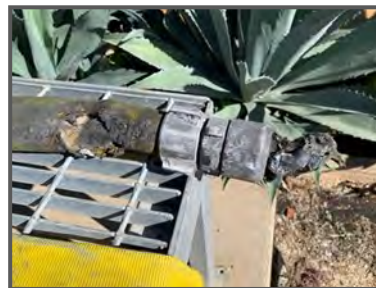
Multiple tools, including firehose, were either unrecoverable or significantly damaged to include 6 rolls of 1 ¾ fire hose and 1 nozzle.

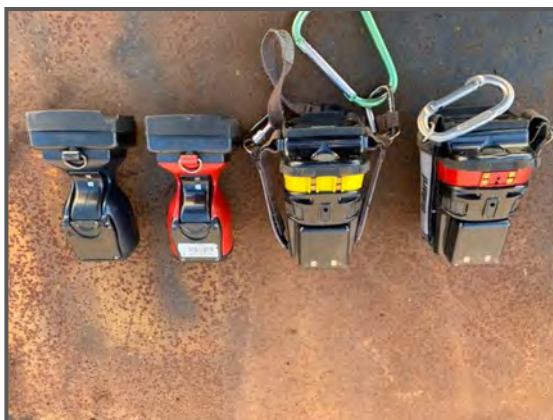
Four Thermal Imaging Cameras were utilized at the fire. Two TIC's malfunctioned at scene and were sent to Bullard for further diagnostic testing. E55's camera had been malfunctioning prior to the fire and the Bullard service technicians recommended several repairs once tested. E51's TIC was tested by the Bullard service technicians and the product performed to the design specifications. In addition, the quality team also conducted high temperature tests with the same results, the imager performed to specification.
